Drawn by D. Pye

March 2017

Kolster-Brandes 169

3 Valve Plus Rectifier AC Mains TRF Receiver

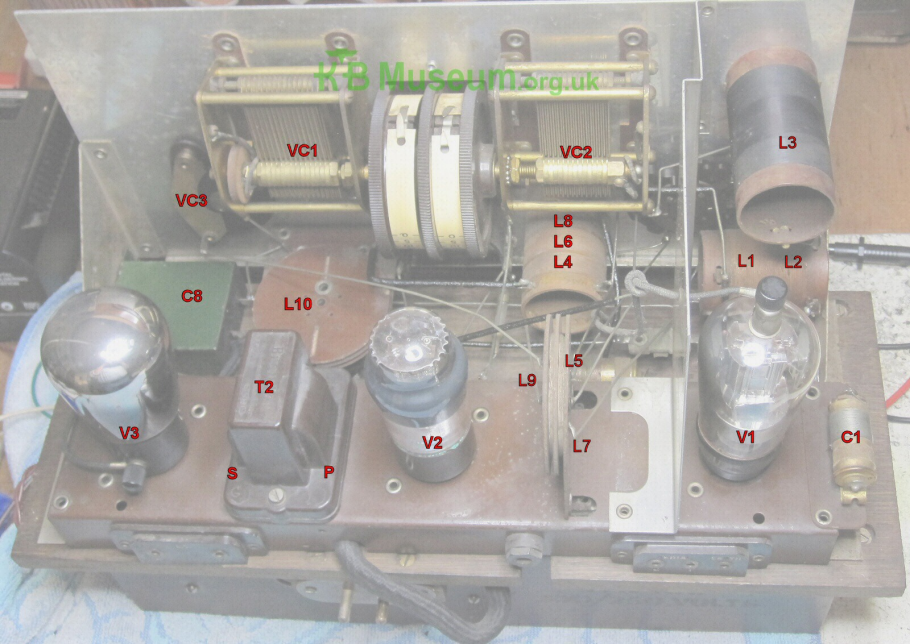
Tone correction circuit 22k & 2.2nF across T2 secondary

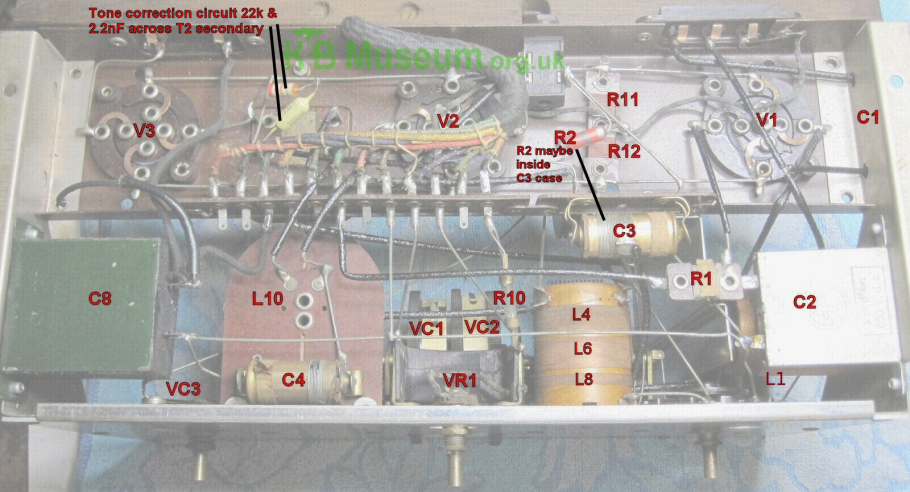
R2 maybe inside C3 case

This circuit has been drawn from a working radio. There may be errors in the drawing so please check your own wiring
